## Electrical geophysical methods to study subsurface water movement in urban areas

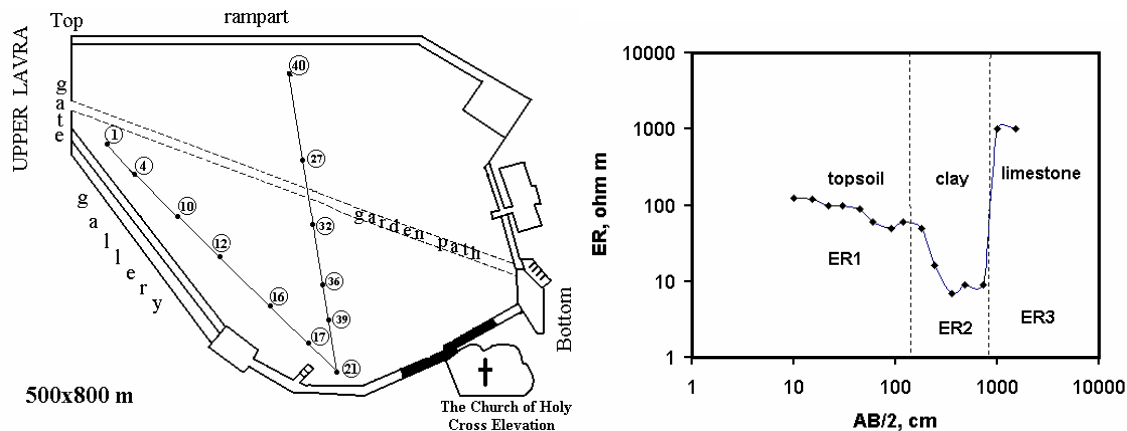
We used the vertical electrical sounding (VES) and electrical profiling (EP) methods to investigate the properties of water-bearing and waterproof layers essential for the development of the subsurface water fluxes. The directions and intensities of the fluxes were evaluated with the self-potential (SP) method (LandMapper ERM-02 can be used).

The VES and EP methods revealed complex stratification of the hill slope in the Patriarch garden near The Church of Holy Cross Elevation (Figs). All the VES curves revealed three-layer soil profile with apparent  $ER_1 > ER_2 < ER_3$ . The top layer was represented by the eroded Chernozem of coarse textures with electrical resistivity ( $ER_1$ ) about 125 ohm m for loamy sand and about 50 ohm m for sandy clay loam. The second layer was a thick clay layer (7 m) with

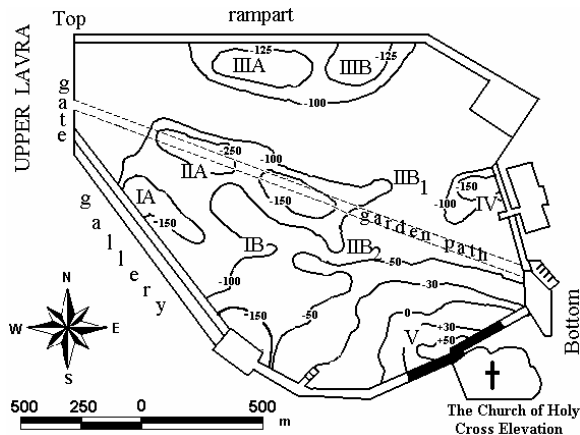
low electrical resistivity ( $ER_2$ ) from 2 to 16 ohm m. The clay was saturated and gleyed in some places, which was indicated by 2 ohm m resistivity. The third layer with the resistivity ( $ER_3$ ) about 2000 ohm m was horizontally deposited limestone. The results of sounding were verified with boring at the same 12 locations. The thickness of clay layer decreased from 8 to 2 m along the line from the top of the hill to the tier wall. The low and almost constant electrical resistivity (8 ohm) for the AB/2 from 3.6 to 7.2 m for the second layer shown that clay did not bear any intrusions of sand or sandy loam, which was verified with boring. Therefore, water flow inside second layer was impossible. The water flow could be formed only in the topsoil over the layer of waterproof clay.

Although undetectable on the surface, three gullies were revealed in the second layer of waterproof clays by the VES and EP methods. The subsurface water flow could be formed in such gullies. The method of self-potential was used to estimate water flux directions and intensities through the measured variation in electrical potential on the soil surface. An iso-potential map (Figure) was developed with the method on a 5 x 10 m grid; 299 locations were measured with five replications. Three major iso-potential areas detected from the figure. Two areas with negative potentials were formed near rampart and along the gallery (including the garden path) and indicated the areas of water infiltration into the soil and development of groundwater flow (I, II, and III). The third area with positive potentials outlined the seepage zone near The Church of Holy Cross Elevation (V). The most negative potentials (-250 mV) along the garden path indicated the most intensive subsurface water flow in this area (IIA, IIB<sub>1</sub>, and IIB<sub>2</sub>). The -250-mV iso-potential area developed in surface peaty sand with electrical resistivity ( $ER_1$ ) about 170 ohm m. The less negative potentials (-150 mV) and, therefore, the less intensive water flow occurred near the gallery (IA and IB). The same negative potential areas were detected in the middle of the garden path and near the rampart (IIIA, IIIB, and IV). The seepage area was outlined by the 0-mV iso-potential near The Church of Holy Cross Elevation (V). The seepage area was enriched with clay material having electrical resistivity about 5 ohm m. The percentage of clay in the soil increased toward the corner of the church along with the electrical potential.
