Be land-wise...
ANDVISER, Inc
24 Bentwood Dr., Westhampton, NJ 08060, USA
Tel. 609-412-0555, Fax. 435-417-0316
info@landviser.com, www.landviser.com

Electrical geophysical methods to study subsurface water movement in urban areas

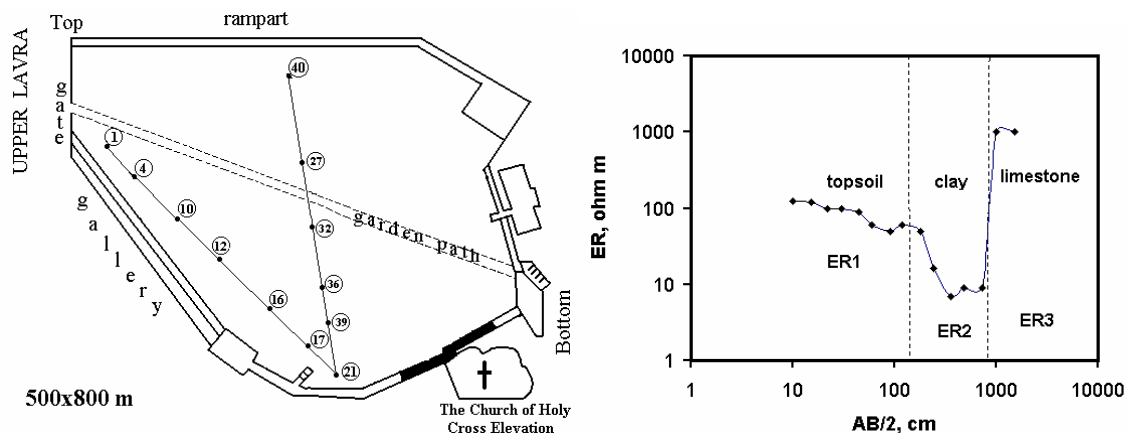
The VES and EP methods revealed complex stratification of the hill slope in the Patriarch garden near The Church of Holy Cross Elevation (Figs). All the VES curves revealed three-layer soil profile with apparent $ER_1 > ER_2 < ER_3$. The top layer was represented by the eroded Chernozem of coarse textures with electrical resistivity (ER_1) about 125 ohm m for loamy sand and about 50 ohm m for sandy clay loam. The second layer was a thick clay layer (7 m) with low electrical resistivity (ER_2) from 2 to 16 ohm m. The clay was saturated and gleyed in some places, which was indicated by 2 ohm m resistivity. The third layer with the resistivity (ER_3) about 2000 ohm m was horizontally deposited limestone. The results of sounding were verified with boring at the same 12

locations. The thickness of clay layer decreased from 8 to 2 m along the line from the top of the hill to the tier wall. The low and almost constant electrical resistivity (8 ohm) for the AB/2 from 3.6 to 7.2 m for the second layer shown that clay did not bear any intrusions of sand or sandy loam, which was verified with boring. Therefore, water flow inside second layer was impossible. The water flow could be formed only in the topsoil over the layer of waterproof clay.

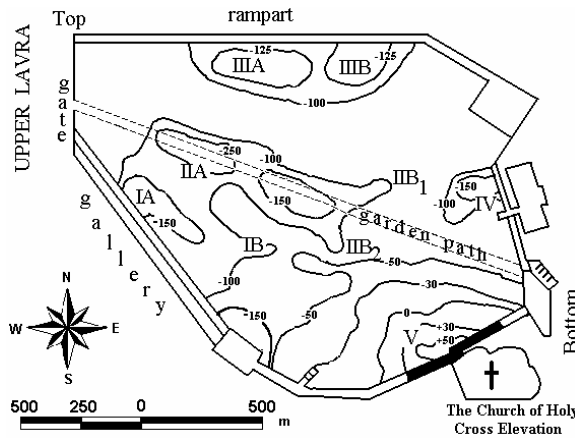
Although undetectable on the surface, three gullies were revealed in the second layer of waterproof clays by the VES and EP methods. The subsurface water flow could be formed in such gullies. The method of self-potential was used to estimate water flux directions and intensities through the measured variation in electrical potential on the soil surface. An iso-potential map (Figure) was developed with the method on a 5 x 10 m grid; 299 locations were measured with

five replications. Three major iso-potential areas detected from the figure. Two areas with negative potentials were formed near rampart and along the gallery (including the garden path) and indicated the areas of water infiltration into the soil and development of groundwater flow (I, II, and III). The third area with positive potentials outlined the seepage zone near The Church of Holy Cross Elevation (V). The most negative potentials (-250 mV) along the garden path indicated the most intensive subsurface water flow in this area (IIA, IIB₁, and IIB₂). The -250-mV iso-potential area developed in surface peaty sand with electrical resistivity (ER₁) about 170 ohm m. The less negative potentials (-150 mV) and, therefore, the less intensive water flow occurred near the gallery (IA and IB). The same negative potential areas were detected in the middle of the garden path and near the rampart (IIIA, IIIB, and IV). The seepage area was outlined by the 0-mV iso-potential near The Church of Holy Cross Elevation (V). The seepage area was enriched with clay material having electrical resistivity about 5 ohm m. The percentage of clay in the soil increased toward the corner of the church along with the electrical potential.

To protect The Church of Holy Cross Elevation, the following procedures were proposed based on our geophysical exploration near the architecture memorial. First, a hedge should be constructed across the gate to the garden to prevent the surface water flow to the Patriarch Garden from the pavement of Upper Lavra. Second, a small dike should be built perpendicular to the gallery and the garden path to direct subsurface water flow from fluxes II and I into the drain system. Third, to enhance evapotranspiration, trees and bushes with the intensive transpiration ability, such as willows and poplars, should be planted along the gallery and rampart, especially in the areas indicated by low potentials. All the measures were implemented in 1990 and still provide adequate preservation for the church and the surrounding caves. The cost of the proposed measures was about one twentieth of the previous construction of concrete wall, which, nevertheless, did not solve the problem of water penetration into the caves.
